Unsafe roads in Kampala: Need to cater for pedestrians with physical disabilities

Unsafe and inequitable roads for disabled pedestrians

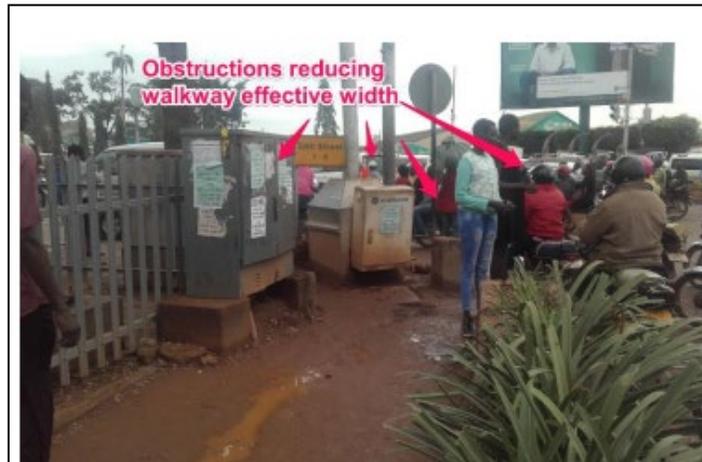
A blocked walkway in Kampala city: Photo source: CEBHA report, 2020

Sensitize the public about the need to keep walkways clear from obstacles, and penalize illegal use of pedestrian space

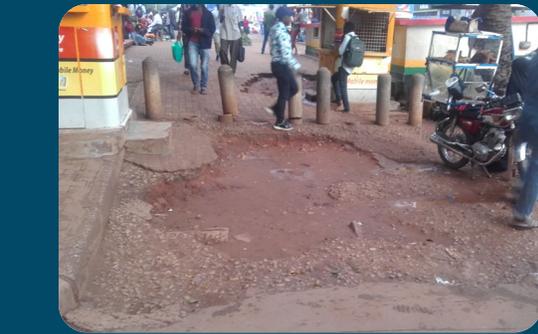
A blocked walkway in Kampala. Photo credit: CEBHA
